Overview

This tragic scenario was exactly the case with the Therac-25, a machine used to treat cancer patients. There were several failures of the Therac-25 system, with at least one directly resulting in the death of the patient. There have been many studies on the Therac-25 system, and the fact that emerges is that the failures were not caused by a single problem, but rather by a series of mistakes made by nearly all of the involved stakeholders. An investigation of the Therac-25 is a fascinating case study in software engineering, both in the history of the system and in the analysis of the problems discovered in the system.

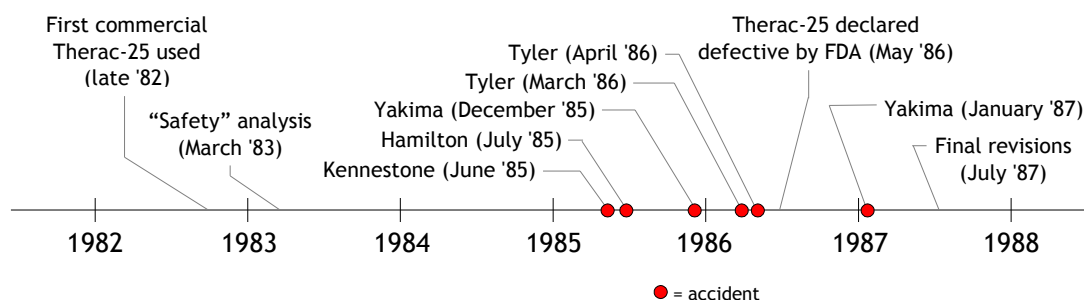
Figure 2. Therac-25 Timeline

There were six accidents as a result of the software error mentioned above. They occurred during the years 1985-1987 across a variety of locations in the United States and Canada. All resulted in significant health problems for the patients and at least two malfunctions directly caused the patient’s death.

The first accident (see Figure 2 for a timeline of all accidents) occurred at the Kennestone Regional Oncology Center in Marietta, Georgia on June 3, 1985. Many of the details of this incident were unclear since it was never reported or investigated, but the patient was a 61-year-old woman who was undergoing radiation treatment for a malignant tumor in lymph nodes near her left breast. A
